**Flood Control Project Maintenance
Levee Inspections**
LMA District Cover Sheet
Spring 2017 Levee Inspection Results

City of Sacramento

Spring 2017 Levee Inspection Results

Waterway			Bank	Unit Miles
Unit No. 01 Sacramento River			Left	3.67
	Spring (March - May)	Summer (June - August)	(September - November) Fall	Winter (December - February)
Unit Maintenance Rating (Fall Only)				
Date of Inspection	3/29/2017 - 3/29/2017			
DWR Inspector	Zach Jojola			
Accompanied By	Dan Velez City of Sacramento

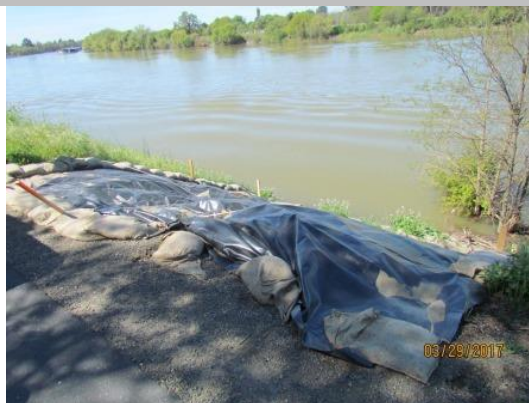
Photo 1 of 1 : SP_2017_NA0005_251_100_20170414_00151.jpg

LM Start	3.61	Rating **	M	Issue No.	100
LM End	3.61	Issue Type +	Ma	Location *	WS
Category	Earthen Levee			GPS Latitude/Longitude	
				Start	End
Item	Erosion / Bank Caving			38.541912 °	38.541912 °
				-121.511014 °	-121.511014 °
DWR ID	DWR_NA0005_01_s_2017_100				
Comment Code					
E1 : Note and monitor erosion site.					
Inspector Comment

Sloughing on waterside levee slope. City of Sacramento placed raincoat to prevent further erosion. Spring 2017.
